**Appendix 3 – Geotechnical Report**

**GEOTECHNICAL ASSESSMENT & RECOMMENDATIONS**  
**to**  
**ENHANCE SLOPE STABILITY**  
**HIGH WALL EXCAVATION**  
**McKENZIE BLOCK, PUKE COAL LTD**

Geotechnical Assessment & Recommendations  
Rotowaro Road, Glen Afton

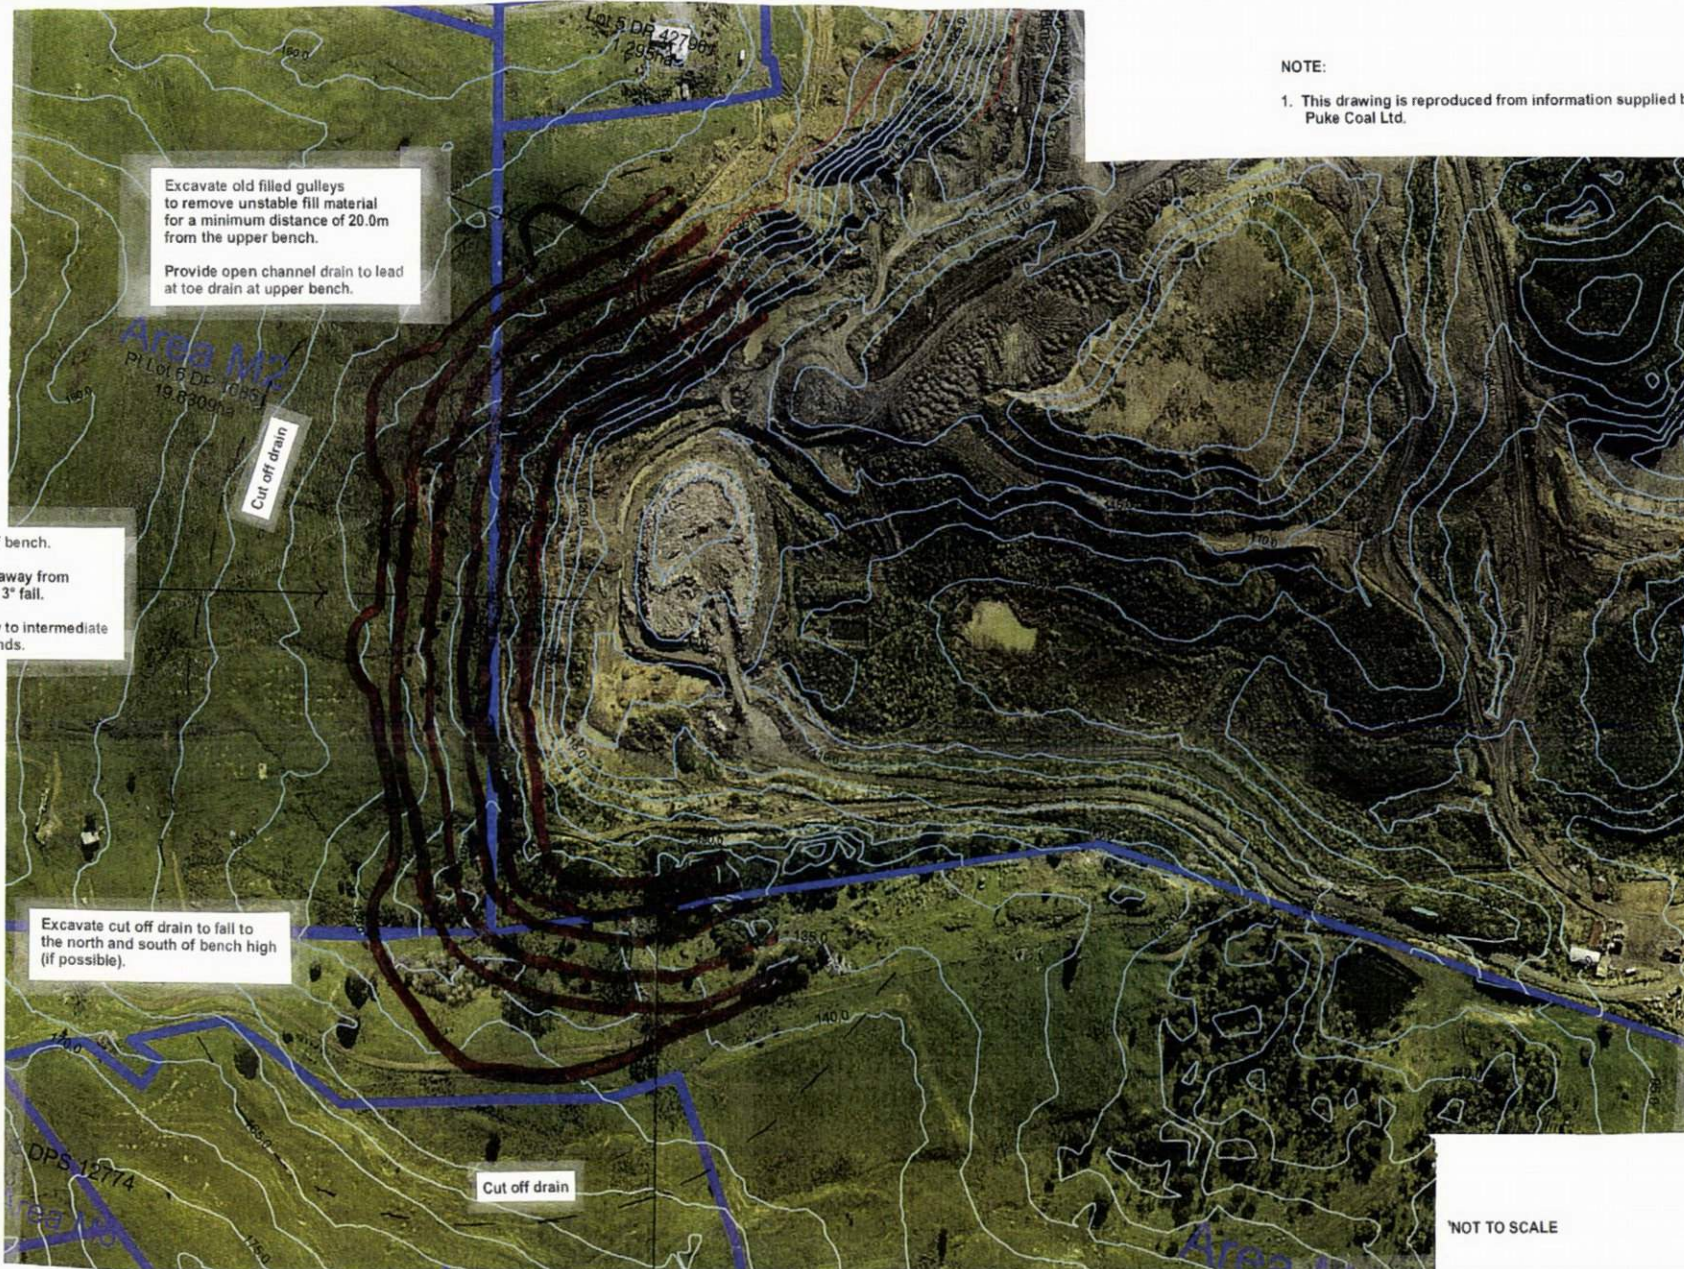
DRAWING No. 14023-01

The locations of the proposed excavations are shown on the attached Drawing No. 14023-01. It will be noted that the toe of the proposed excavation passes to the immediate west of the Construction & Demolition Landfill and extends into the adjacent property, which has been purchased by Puke Coal Ltd in the past year. Prior to that time, stabilisation of the highwall batter slopes was ineffective as it was not possible to extend the earthworks beyond the western boundary. As a result, slope instability has occurred along parts of the highwall face in this locality over the past several years.

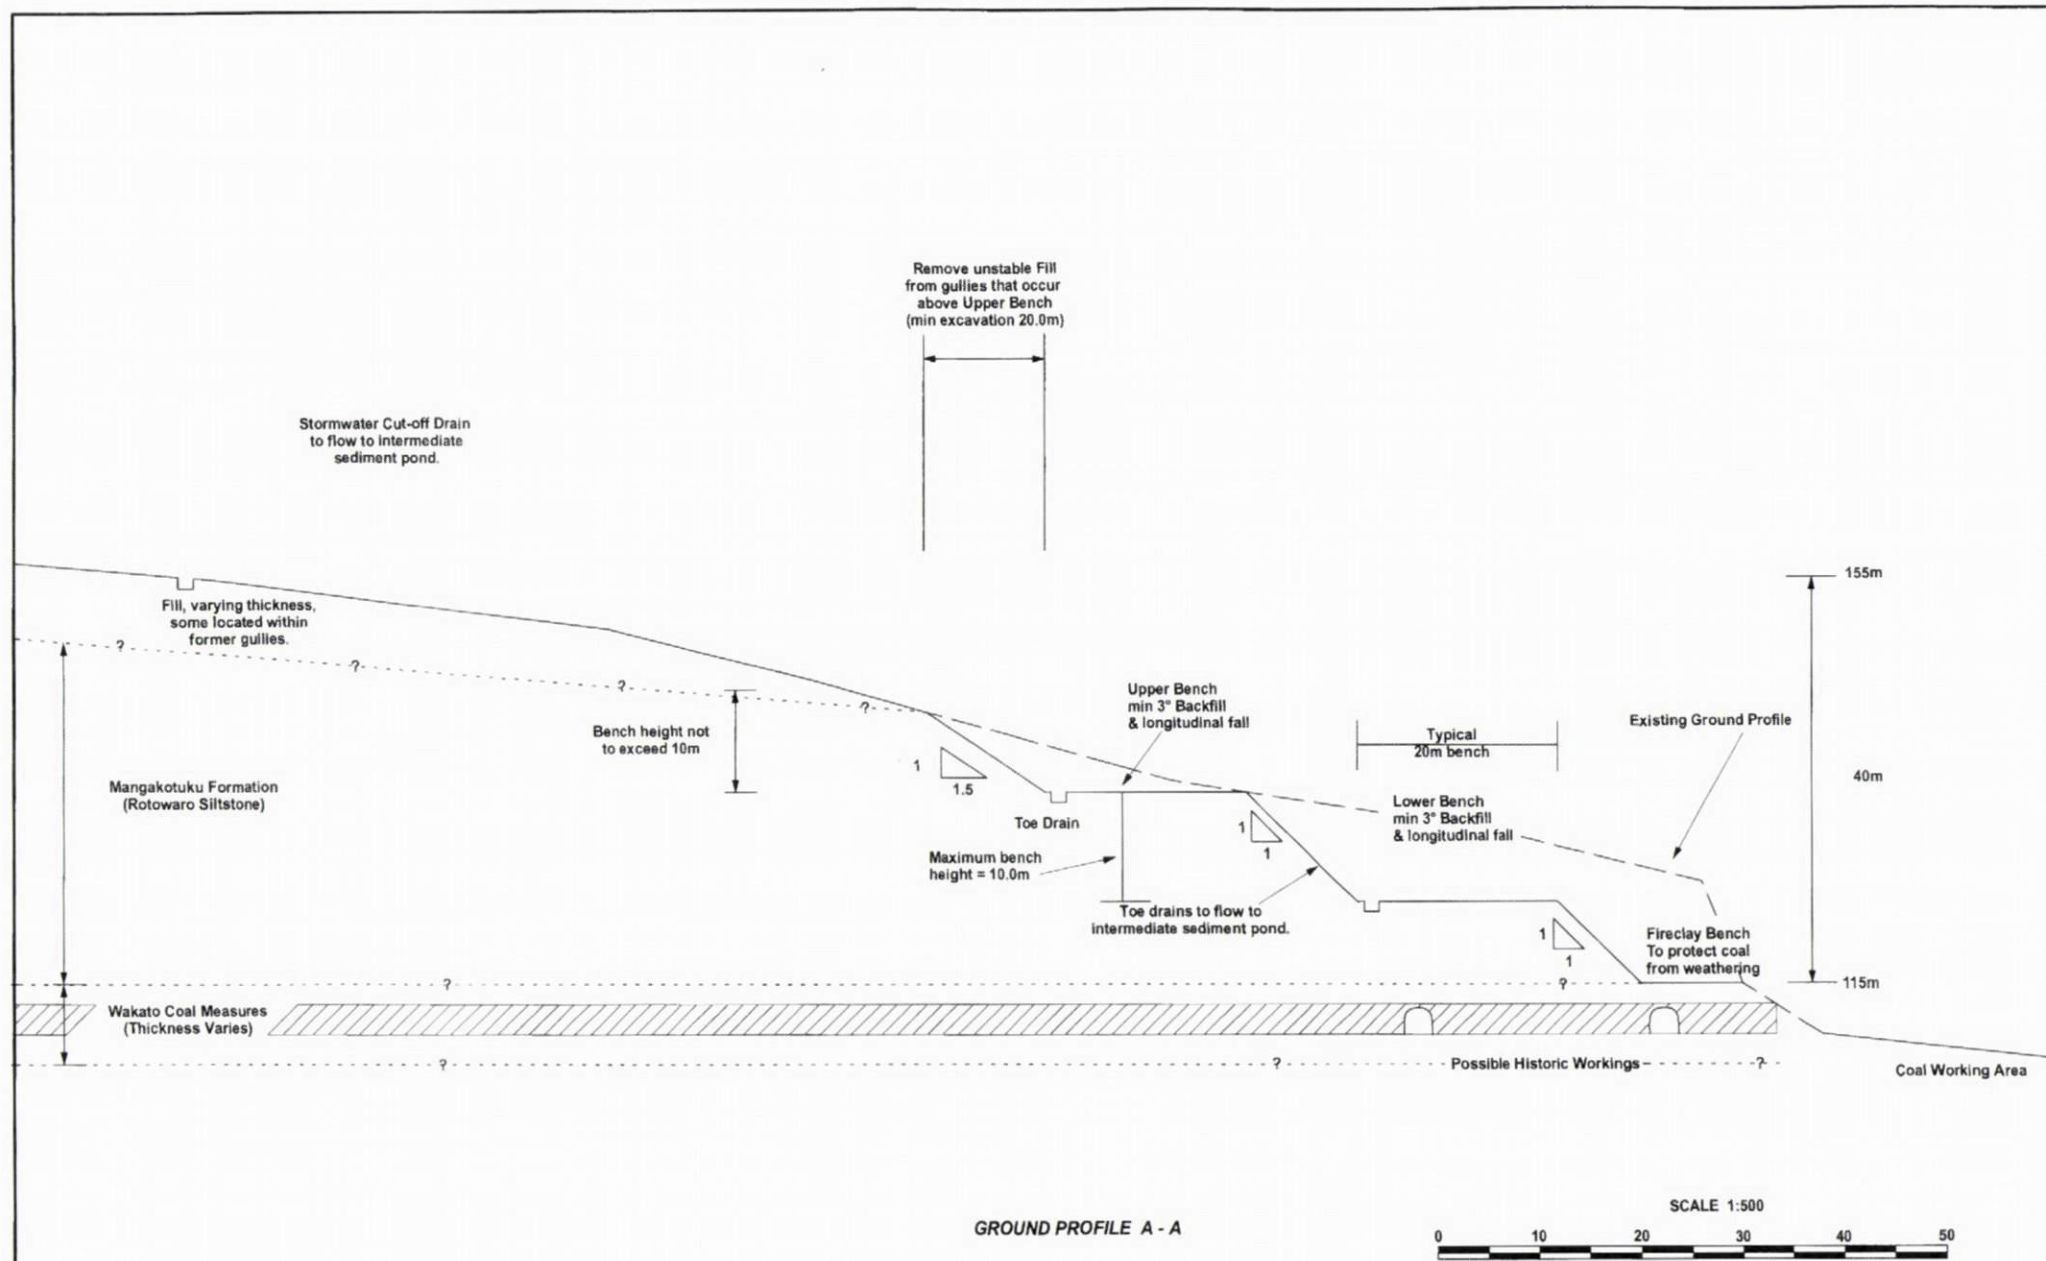
DRAWING No. 14023-02

A typical cross section of the proposed slope stabilisation works is presented on Drawing No. 14023-02. It will be noted that a series of toe drains are planned, with the benches each formed with at a minor crossfall towards the inner part of the excavation. A high point in each of the benches is to be formed midway along the excavation face, with the longitudinal gradient set at about 3 degrees so as to provide well-drained benches that will also serve as haul-road routes.

Within the proposed area of earthworks, areas of instability have occurred, which have been the result of a combination of earthfilling, particularly within former gully areas, together with overland flow of stormwater and some groundwater seepages. Therefore, within this location a lower cut slope angle of 45 degrees is recommended with a maximum bench height of 10 metres. This is particularly important for the bottom excavation which directly overlies the coal measures.

It is further recommended that the siltstone level of the lower bench be maintained at about 2 metres above the level of the coal deposit so as to avoid potential contamination of the coal in the event of near-surface instability of the slopes above. This layer would also minimise the risk of the excavator dropping into former workings within the coal deposit.
